# Manhole Inspection Summary

Manhole # S49CC\_016MH

Insp Date: **6/16/08 8:50 AM**

**Location** Address: **Luzerne**

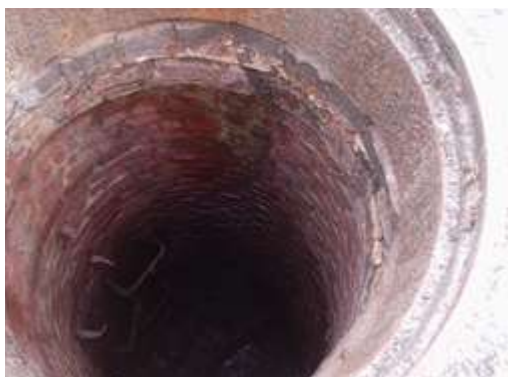
Defect 2

☒ **Leaks**

frame leaks

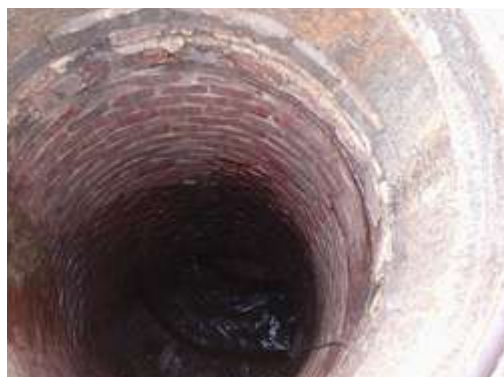
Defect 1

loose bricks

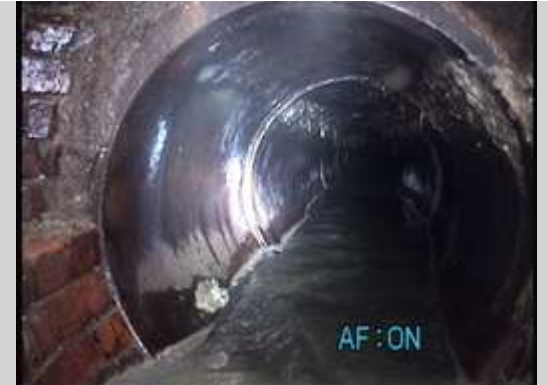
12 O'Clock Outflow

24 in. Circular Gravity Sewer  
Pipe Out @ 12 O'Clock

Pipe Height: **24** (in.) Rod and Bar (Angled)  
Pipe Material: **Clay** ☐ Pipe Lined  
Invert Depth: **14.60** (ft.) Flow Characteristics: **Fast**  
Deposits: ☒ None ☐ Mud ☐ Sludge ☐ Debris ☐ Grease  
Silt Depth: (in.) Deposits Extent:  
Infiltration: **None** Pipe Seal Cond: **Sound**

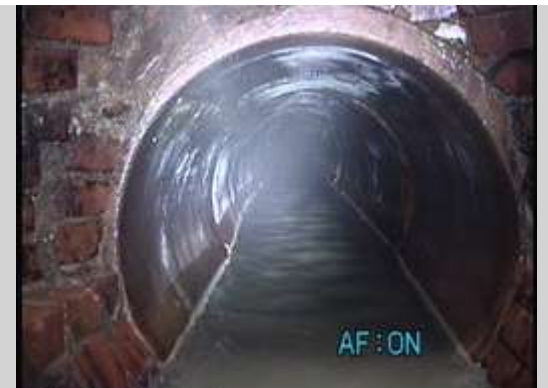
3 O'Clock Inflow

24 in. Circular Gravity Sewer  
Pipe In @ 3 O'Clock

Pipe Height: **24** (in.) Rod and Bar (Angled)  
Pipe Material: **Clay** ☐ Pipe Lined  
Invert Depth: **14.55** (ft.) Flow Characteristics: **Fast**  
Deposits: ☒ None ☐ Mud ☐ Sludge ☐ Debris ☐ Grease  
Silt Depth: (in.) Deposits Extent:  
Infiltration: **None** Pipe Seal Cond: **Sound**
